Home Inspection Report

111 Your Drive, La Vergne, TN 37086

Saturday February 8, 2020

OID54

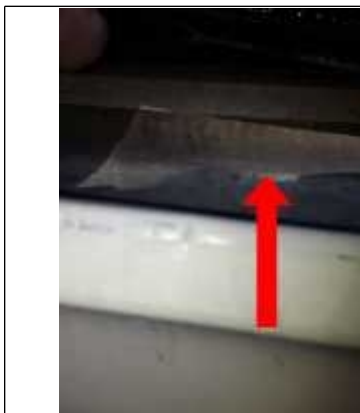
- The drip edge flashing at eaves is missing or improperly installed. Recommend a licensed contractor repair/replace as needed.

No drip edge flashing

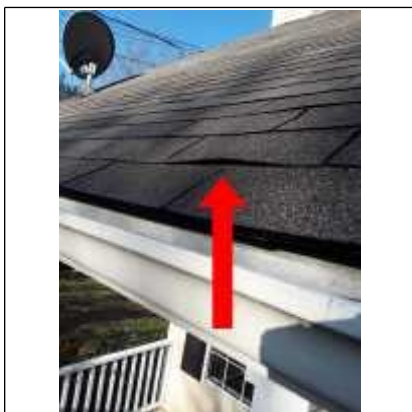
- Some nail popping has occurred. Recommend a licensed contractor repair.
- There are missing tabs or shingles. Recommend a licensed contractor repair or replace.
- The roof has areas of missing granules consistent with hail damage. Recommend a licensed contractor evaluate and repair as needed.

Nail pops

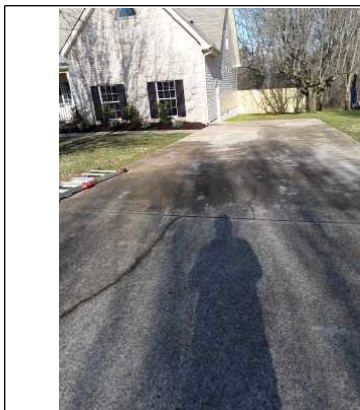
Trip hazard

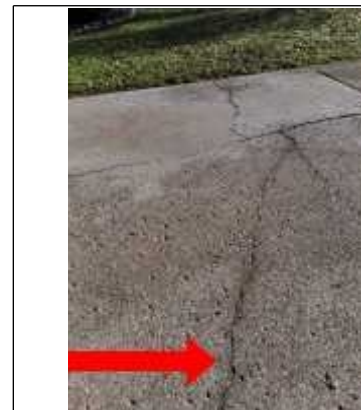
Typical/expected cracks

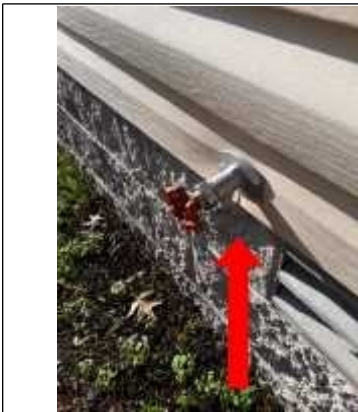
- The hose bib(s) not equipped with anti-siphon devices. This is a safety concern as possible cross connection can occur. Recommend installing anti-siphon device.

Not anti siphon

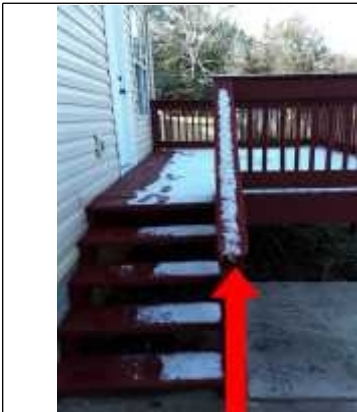
Wrong shape

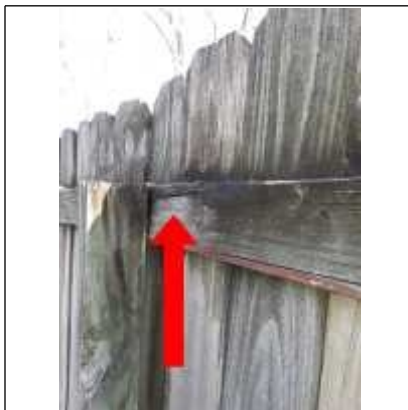
Damage from not being treated

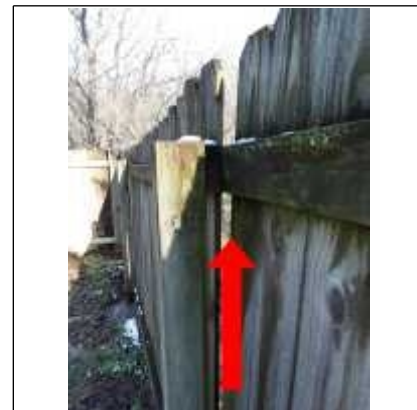
Pulling apart

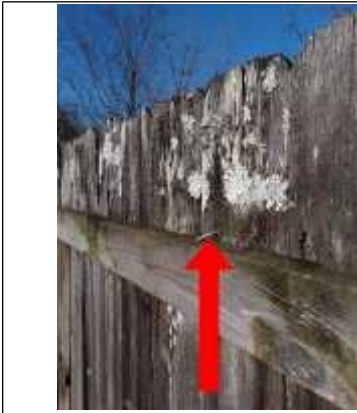
Exposed nail and deteriorating wood

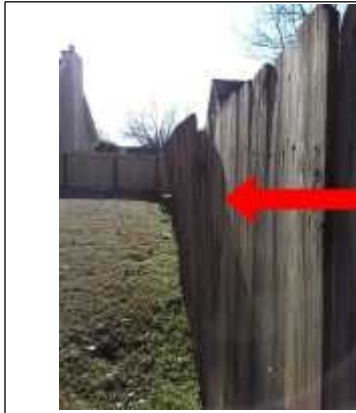
Panel falling off

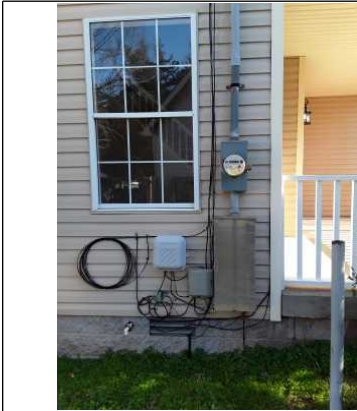
- The overhead wires run through trees. This could cause a safety hazard if wires get compromised. Recommend trimming the trees and contacting utility company for repairs if needed.

Wires in tree

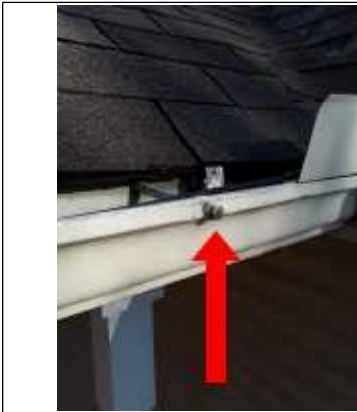
Spikes pulling out

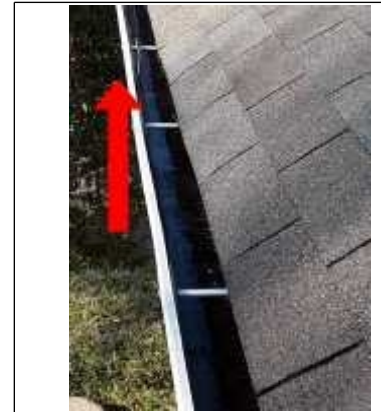
Full of debris and not draining

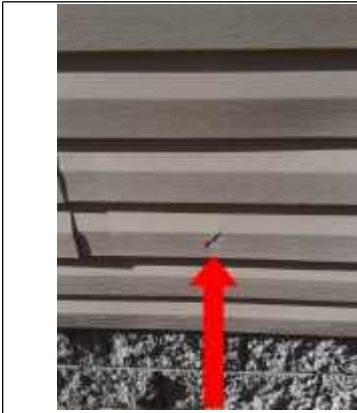
- The siding had some damage. Recommend a licensed contractor repair/replace damaged sections.

Damaged

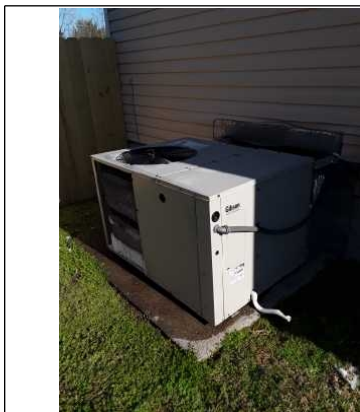
Comments • The heat pump frosted, under normal conditions it should automatically defrost. Monitor and contact a licensed HVAC contractor should it lose efficiency.
 • The life expectancy of a heat pump is 15 to 20 years. Recommend budgeting for replacement since age cannot be determined due to no data plate.

Frosted

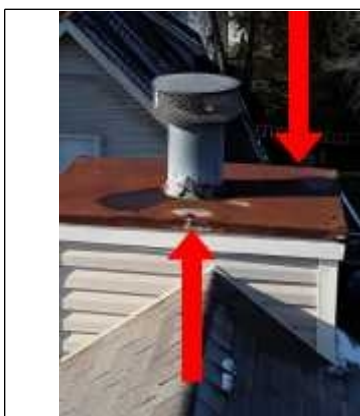
- The chimney cap is rusted with a nail coming loose. Recommend a licensed contractor repair/replace as needed.

Rust and nail coming out

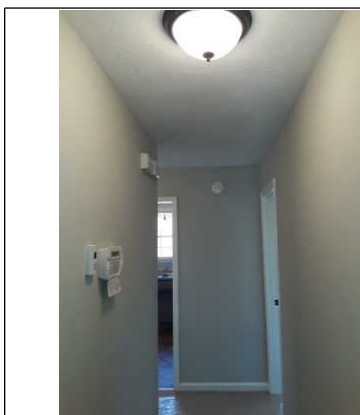
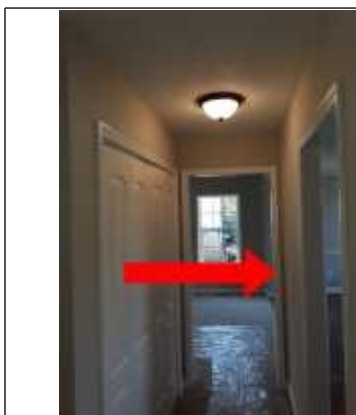
- The light in the first floor hallway does not operate when switched unless switch on other end of hall is on. Recommend a licensed electrician evaluate and repair/replace as needed.

Switches are not three way

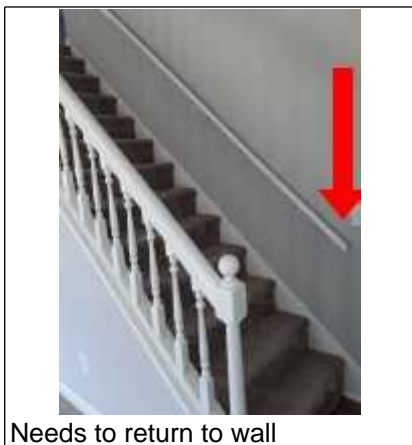
- The handrail does not return to the wall. This is a potential safety concern. Recommend repair by a licensed contractor.

Needs to return to wall

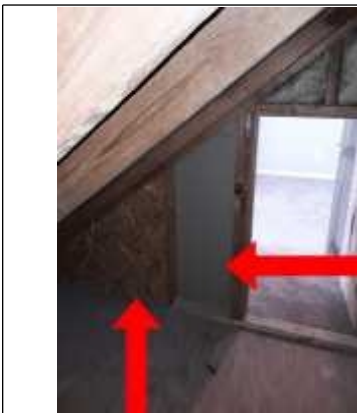
- The insulation in the attic is missing in one or more locations. Recommend additional insulation be installed by licensed contractor.
- The vapor barrier is installed improperly. The vapor barrier should be installed at the conditioned side of structure. Recommend evaluation and repair by a qualified contractor.
- There are bathroom vents with damaged piping in the attic. Recommend repairing piping so it vents to the exterior.
- The spring in the pull down steps to access the attic does not have a safety cable. This is a safety concern. Recommend a licensed contractor evaluate and repair/replace as needed.

Insulation missing and installed incorrectly

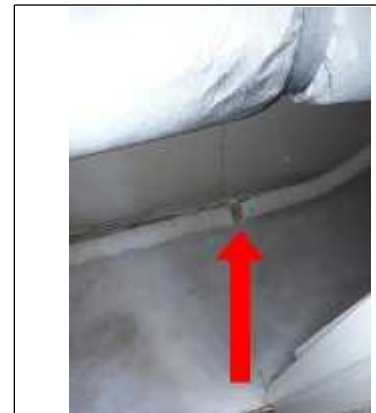
Damaged bathroom vent piping

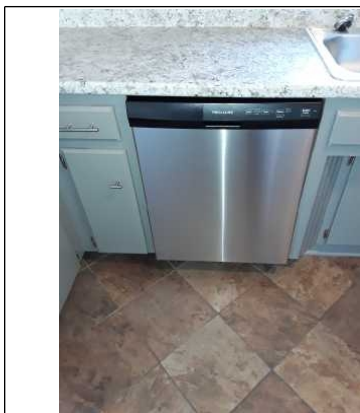
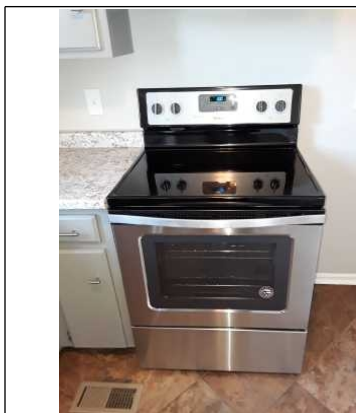
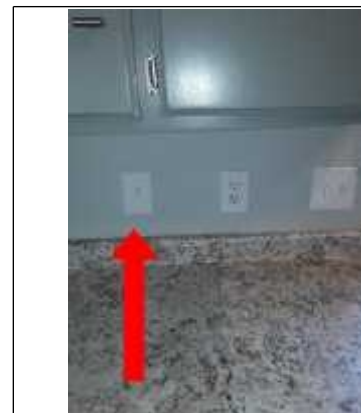
- The dishwasher door would not open and will not cancel or complete cycle. Recommend repair by licensed plumber.
- There is one switch that use could not be determined.

Unknown switch

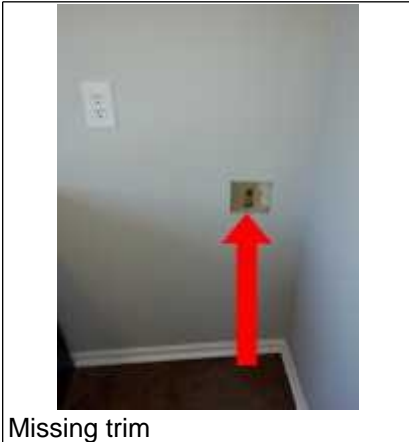
- The trim for the water supply is missing. Recommend a licensed contractor repair as needed.

Missing trim

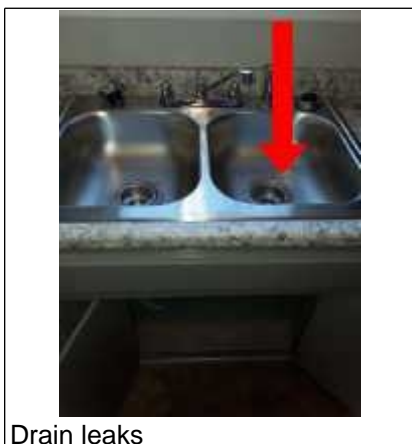
- The drains show signs of leakage. Recommend repair by a licensed plumber.
- The hot water valve is leaking. Recommend repair by a licensed plumber.

Drain leaks

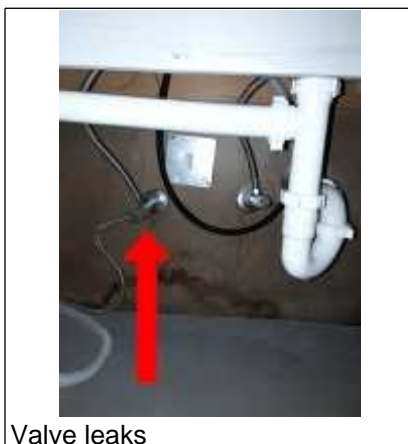
Valve leaks

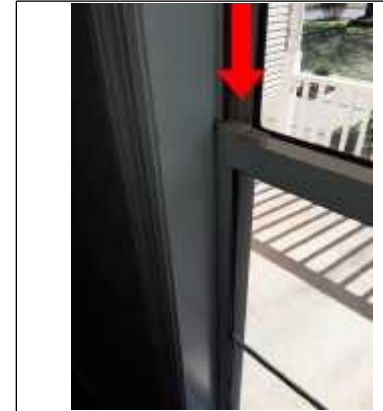
- At least one window has some damage and/or hardware in not operable. Recommend a licensed contractor evaluate and repair/replace as needed.

Clip will not set

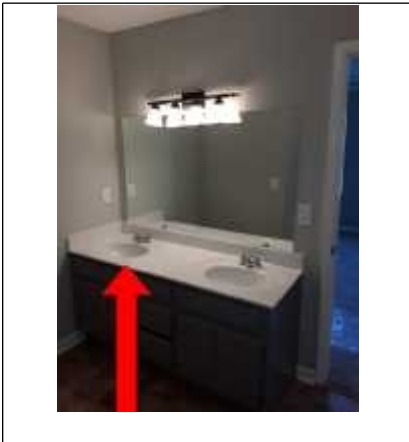
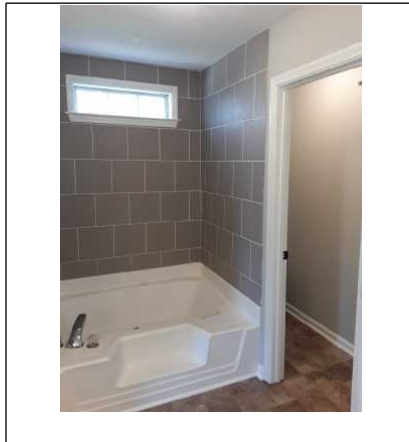
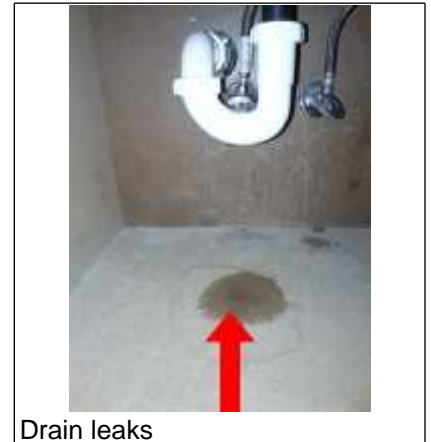
Comments • The drain is leaking in the bathroom. Recommend repair and/or replacement by licensed plumber.

Drain leaks

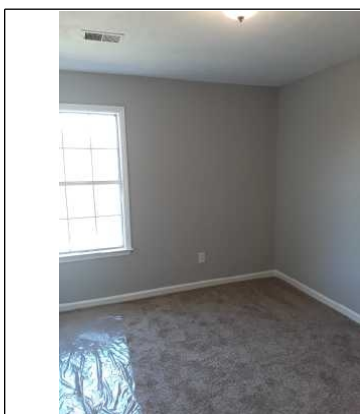
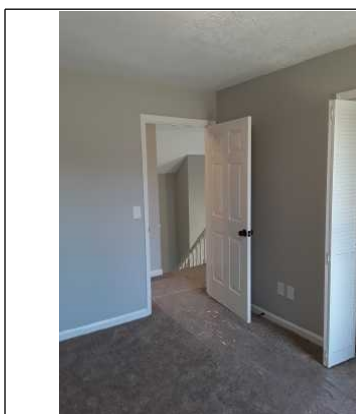
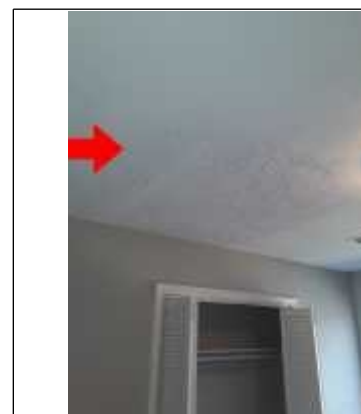
Previously repaired ceiling

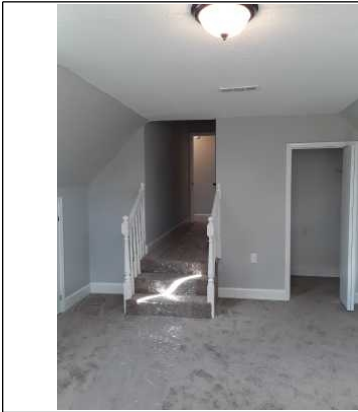
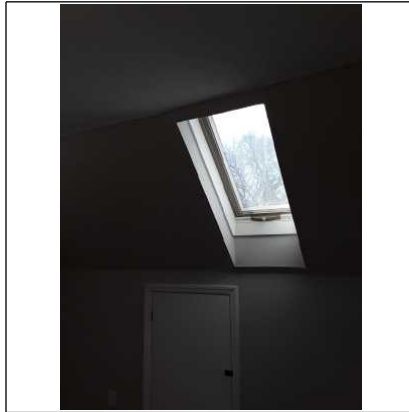
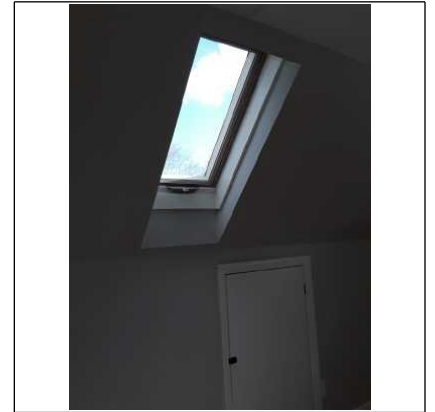
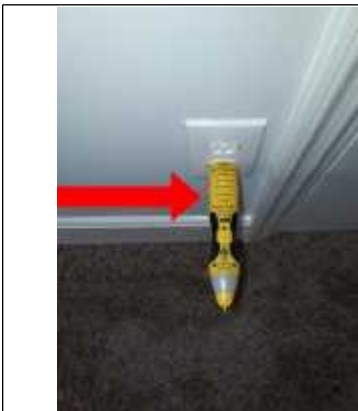
- There is reversed polarity in at least one receptacle. This is a safety concern. Recommend a licensed electrician repair.
- There is a open ground in at least one receptacle. This is a safety concern. Recommend a licensed electrician repair.

Ground and neutral are reversed

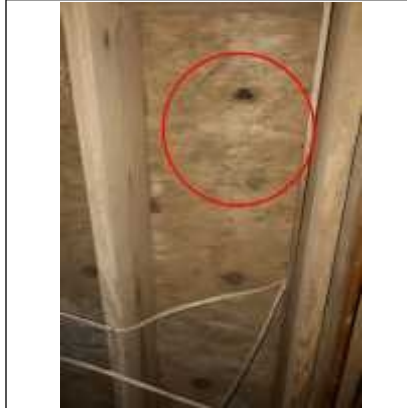
- The basement/crawlspace had some minor microbial growth. Recommend monitoring to ensure moisture remains minimal.
- There was a dryer vent terminated in the crawlspace and covered many areas with dryer lint. Appears to have been corrected.

Minor microbial growth

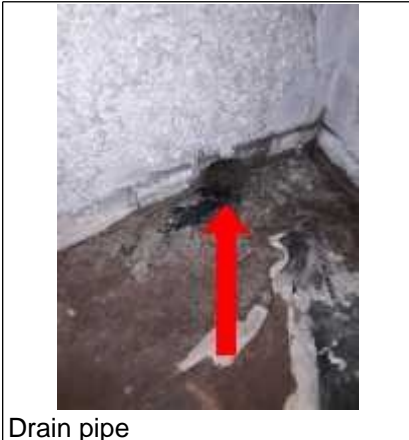
- There is a drain pipe running into the back yard and no standing water at the time of the inspection. Recommend monitoring crawlspace to ensure water is draining out properly. Contact a licensed contractor to evaluate and repair/replace as needed.

Drain pipe

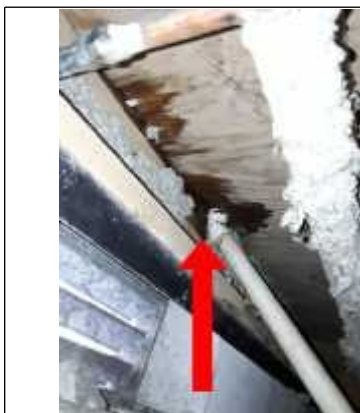
- The area under the kitchen sink has active moisture stains present. Recommend a licensed plumber evaluate and repair as needed.

Active leak
