Home Inspection Report

111 Your Drive, La Vergne, TN 37086

Saturday February 8, 2020

OID54

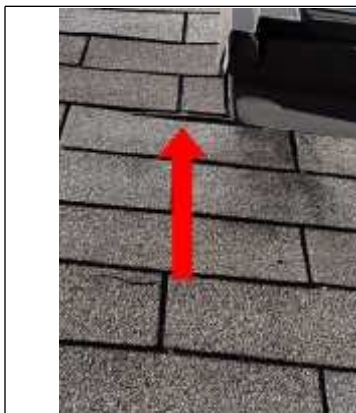
- The drip edge flashing at eaves is missing or improperly installed. Recommend a licensed contractor repair/replace as needed.

No drip edge flashing

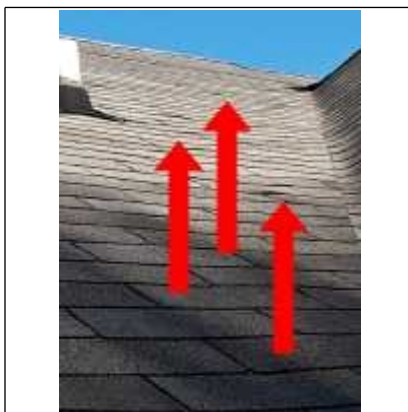
- Some nail popping has occurred. Recommend a licensed contractor repair.
- There are missing tabs or shingles. Recommend a licensed contractor repair or replace.
- The roof has areas of missing granules consistent with hail damage. Recommend a licensed contractor evaluate and repair as needed.

Numerous nail pops

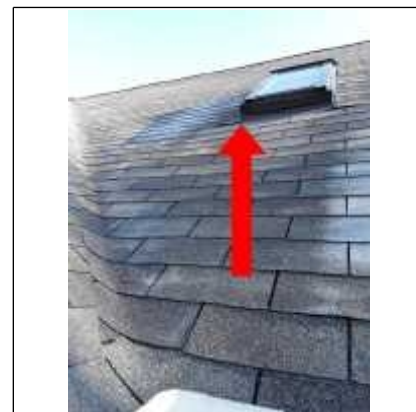
Roof #1 ☒ Marginal ☒ Curling ☒ Nail popping ☒ Granules missing ☒ Missing Tabs/Shingles/Tiles
☒ Recommend roofer evaluate

Curling

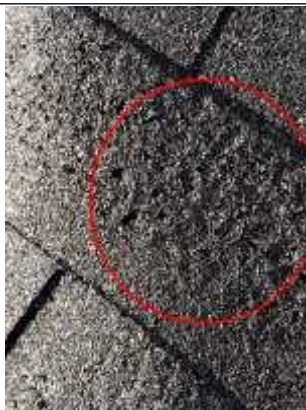
Missing granules

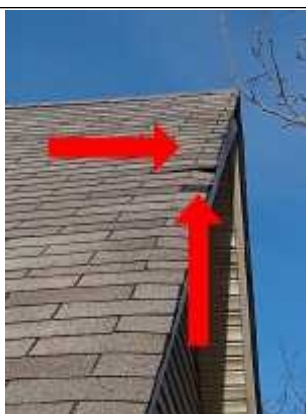
Damaged and missing tabs

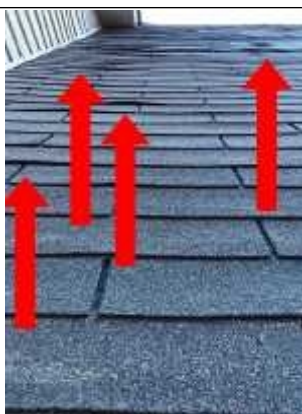
Nail pops

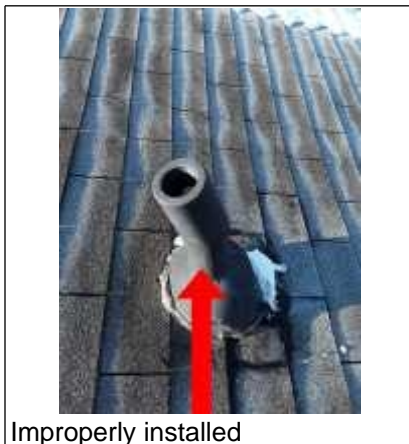
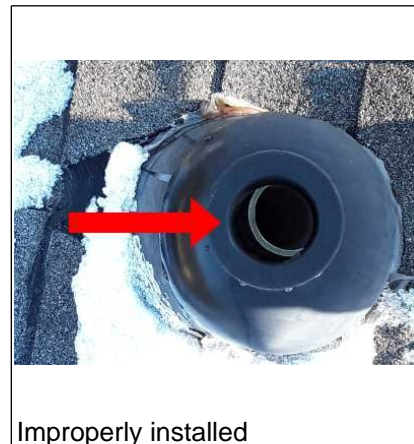
- The plumbing vents have patched with tar. Tar is a temporary solution. Recommend a licensed contractor evaluate and repair/replace as needed.
- The vent boot covering are not properly installed. This may allow water intrusion. Recommend a licensed roofer repair/replace as needed.

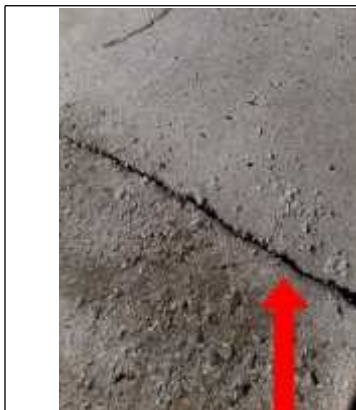
- There is a trip hazard in the driveway. This is a safety concern. Recommend a licensed contractor repair and/or replace.
- There are some typical/expected cracks in the driveway. Recommend sealing the cracks to help prevent damage from water penetration.

Trip hazard

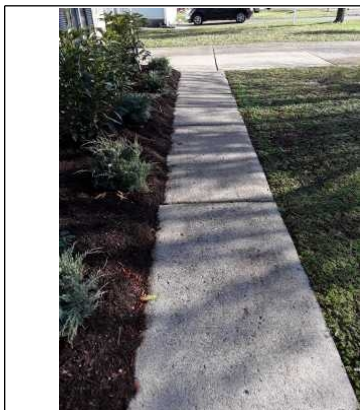
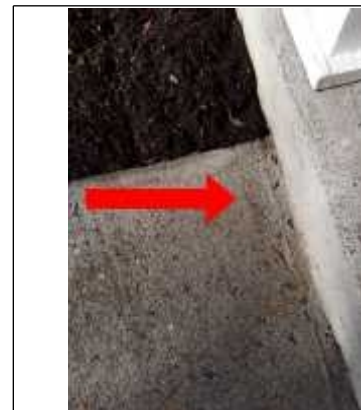
Typical/expected cracks

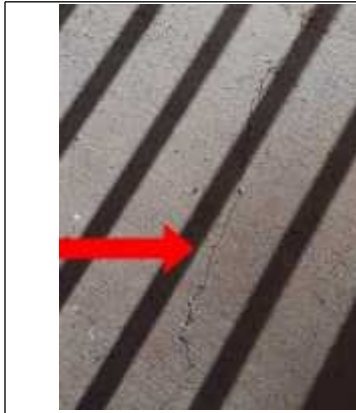
Typical/expected cracks

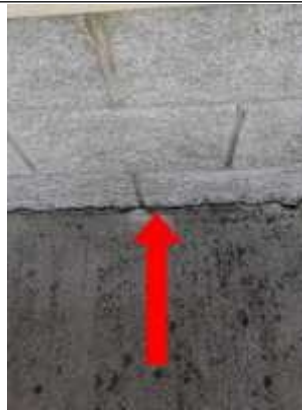
Seal gap

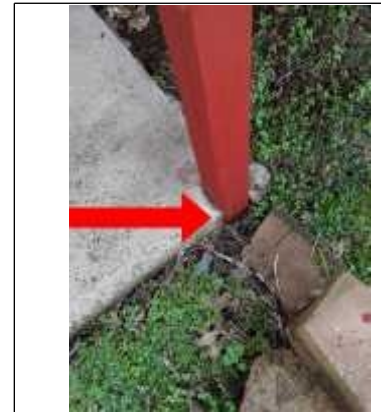
In contact with soil and concrete

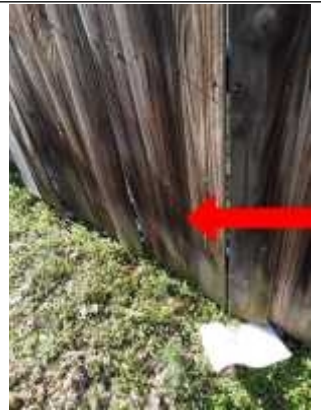
- The fencing is not part of the home inspection. All comments are for courtesy purposes only.
- The fence has some extensive damage and is in need of extensive repair and/or replacement.
- The fence is in need of painting/staining to prevent wood damage.
- The fence is leaning out in the back. Recommend leveling all post to straighten fence.

Loose boards

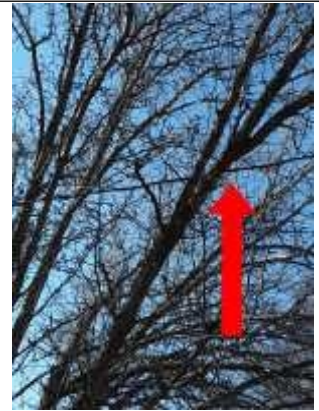
- The overhead wires run through trees. This could cause a safety hazard if wires get compromised. Recommend trimming the trees and contacting utility company for repairs if needed.

Wires in tree

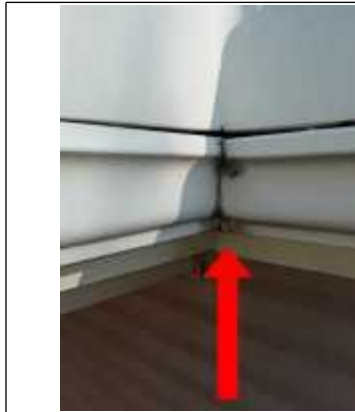
Corner leaks

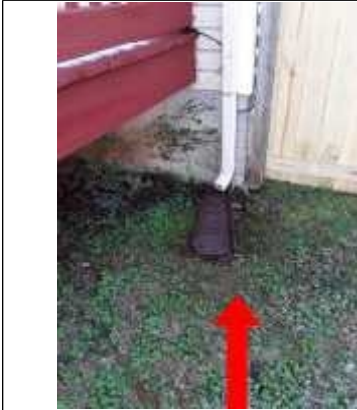
- The gutters had some damage. Recommend repairing/replacing the damaged sections by a licensed contractor.
- Recommend adding downspout extensions to discharge away from the house. 5-6' extensions recommended.

Need extensions

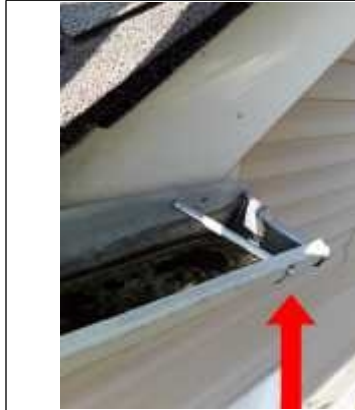
Damaged

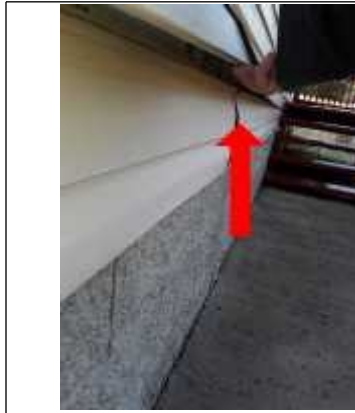
- The siding had some damage. Recommend a licensed contractor repair/replace damaged sections.

Siding not in channels

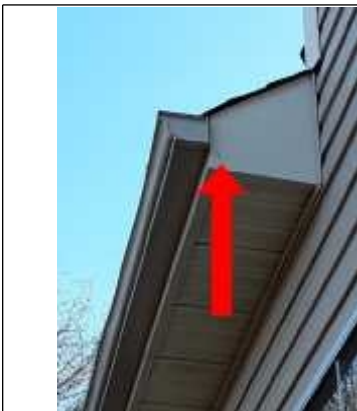
- The fascia is covered with aluminum/steel and structure underneath is not visible. Inspection comments do not include unseen items.
- The nails are pulling loose from some of the fascia. Recommend a licensed contractor evaluate and repair/replace as needed.

Nails backing out

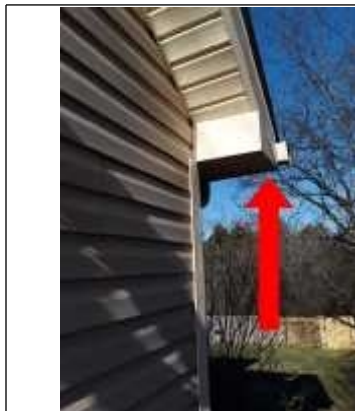
Nails backing out

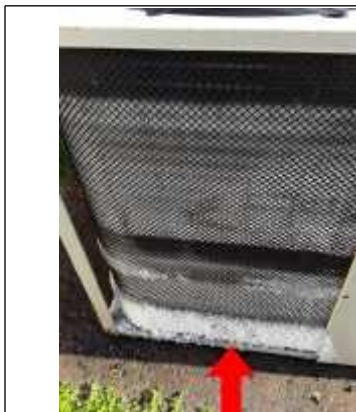
Comments • The heat pump frosted, under normal conditions it should automatically defrost. Monitor and contact a licensed HVAC contractor should it lose efficiency.
 • The life expectancy of a heat pump is 15 to 20 years. Recommend budgeting for replacement since age cannot be determined due to no data plate.

Frosted

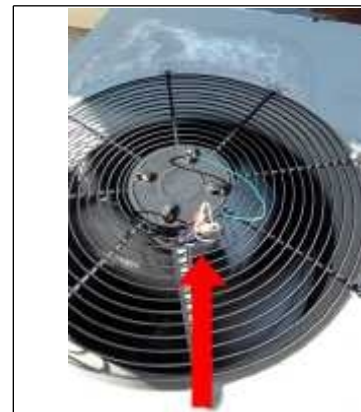
Fan motor wiring

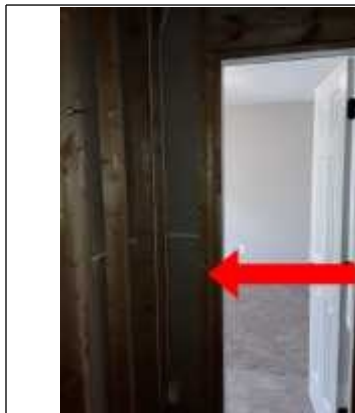
- The insulation in the attic is missing in one or more locations. Recommend additional insulation be installed by licensed contractor.
- The vapor barrier is installed improperly. The vapor barrier should be installed at the conditioned side of structure. Recommend evaluation and repair by a qualified contractor.
- There are bathroom vents with damaged piping in the attic. Recommend repairing piping so it vents to the exterior.
- The spring in the pull down steps to access the attic does not have a safety cable. This is a safety concern. Recommend a licensed contractor evaluate and repair/replace as needed.

Insulation missing

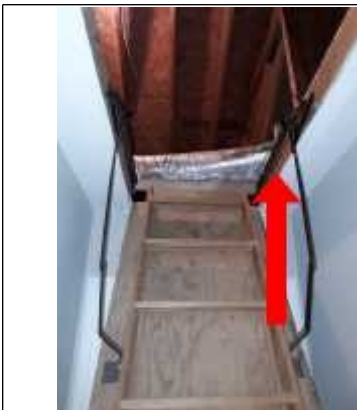
Missing safety cable

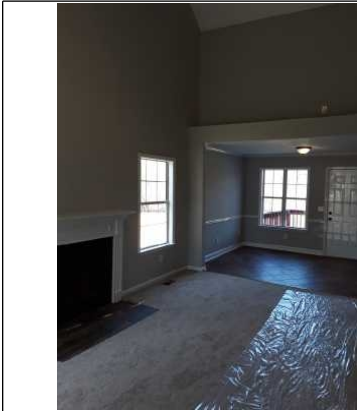
- At least one window has some damage and/or hardware in not operable. Recommend a licensed contractor evaluate and repair/replace as needed.

Clip will not set

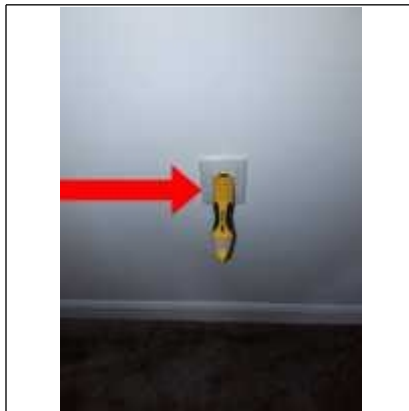
- There is reversed polarity in at least one receptacle. This is a safety concern. Recommend a licensed electrician repair.
- There is a open ground in at least one receptacle. This is a safety concern. Recommend a licensed electrician repair.

Open ground

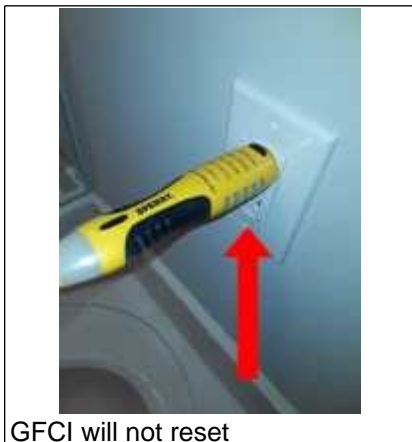
- The GFCI outlet will not reset. This is a safety concern. Recommend replacing GFCI by licensed electrician.

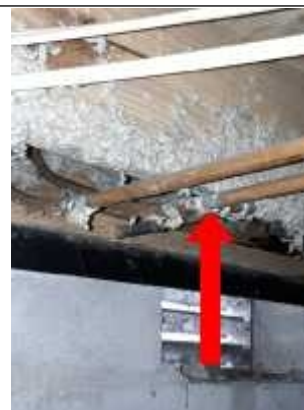
Comments • At least one supply pipes is corroded. Recommend the pipes be monitored and repaired and/or replaced by a licensed plumber as needed.

Corrosion

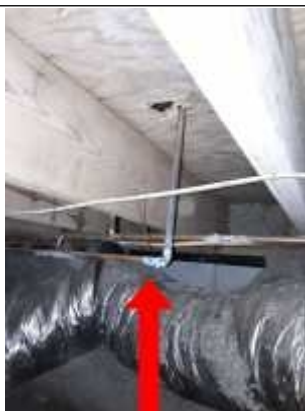
Corrosion

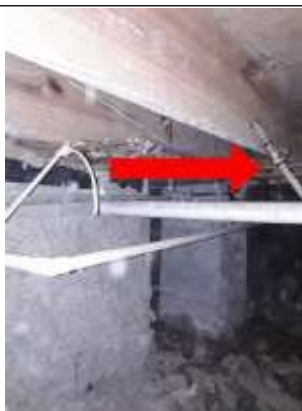
Unknown PEX

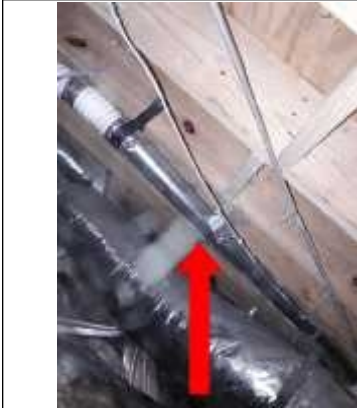
- The basement/crawlspace had some minor microbial growth. Recommend monitoring to ensure moisture remains minimal.
- There was a dryer vent terminated in the crawlspace and covered many areas with dryer lint. Appears to have been corrected.

Repaired dryer vent

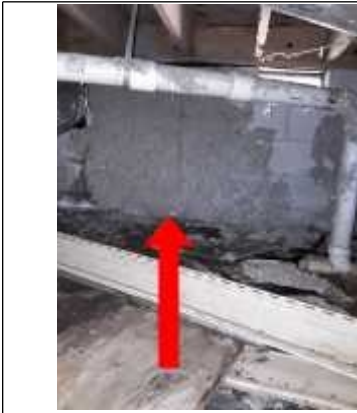
- The foundation walls were covered in many areas with dryer lint and were not visible.
- The foundation walls have efflorescence indicating that water has been present. There was not any moisture present at the time of the inspection. Recommend monitoring for moisture and contacting a licensed contractor as needed.

Dryer lint

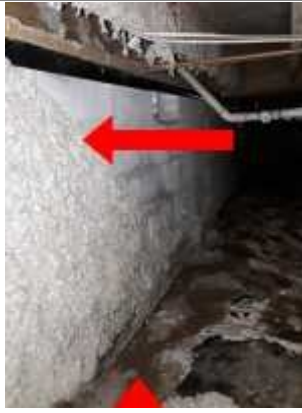
Walls covered with dryer lint and damp floor

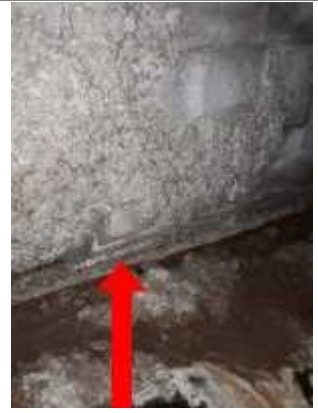
Efflorescence

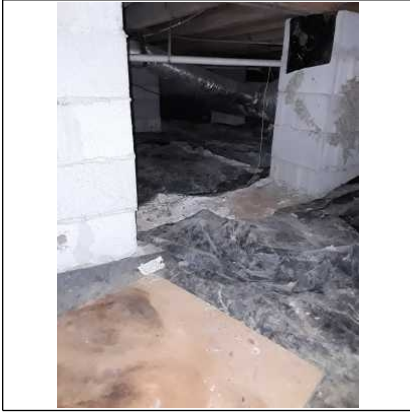
- The poly sheeting on the floor was not properly installed. Recommend a qualified contractor repair as needed to limit moisture in the crawl space.
